ROCKFALL PROTECTION AT GOODVIEW HEIGHTS TOWNSHIP, SG LONG, SEL SUNGAI LONG, SELANGOR, MALAYSIA

Simple Drapery

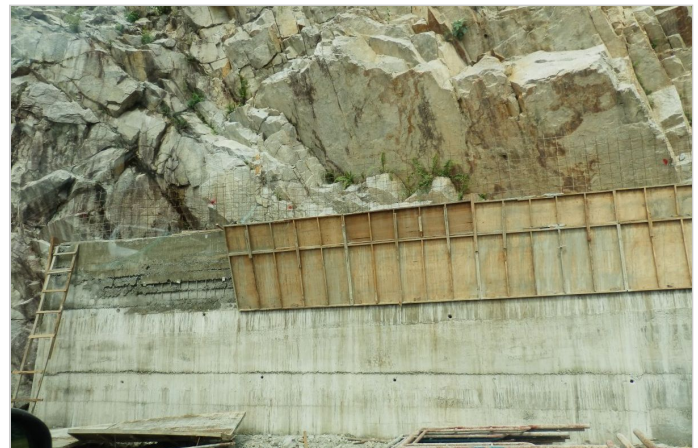
During Construction

Maccaferri Galfan Steelgrid™ G8/3.0 was laid on top of the rock slope, with rock bolts anchoring at every 3m spacing. This acted to strengthen and prevent detachment of any loose rocks from the rock surface. An estimated of 1800 m2 with a height up to 30m are to be protected and covered. Galfan Steelgrid™ which is made of zinc-aluminium alloy coating to better corrosion protection is a netting consist of steel cables weaved longitudinally into wire mesh. This enhances the drapery stiffness, thus effectively transfers all heavy stress to the rock bolts.

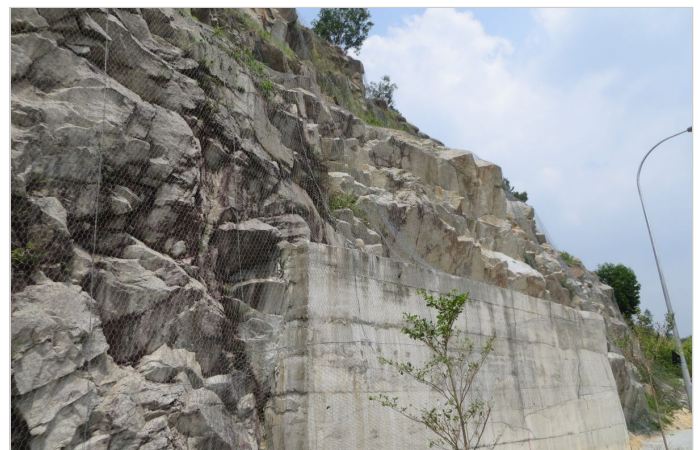
after construction

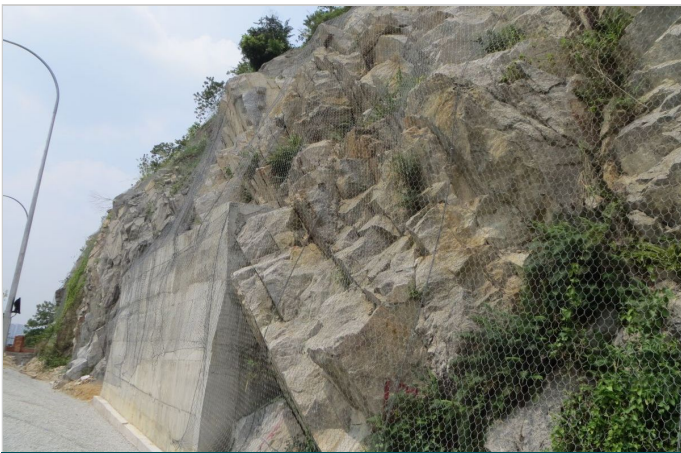
after construction

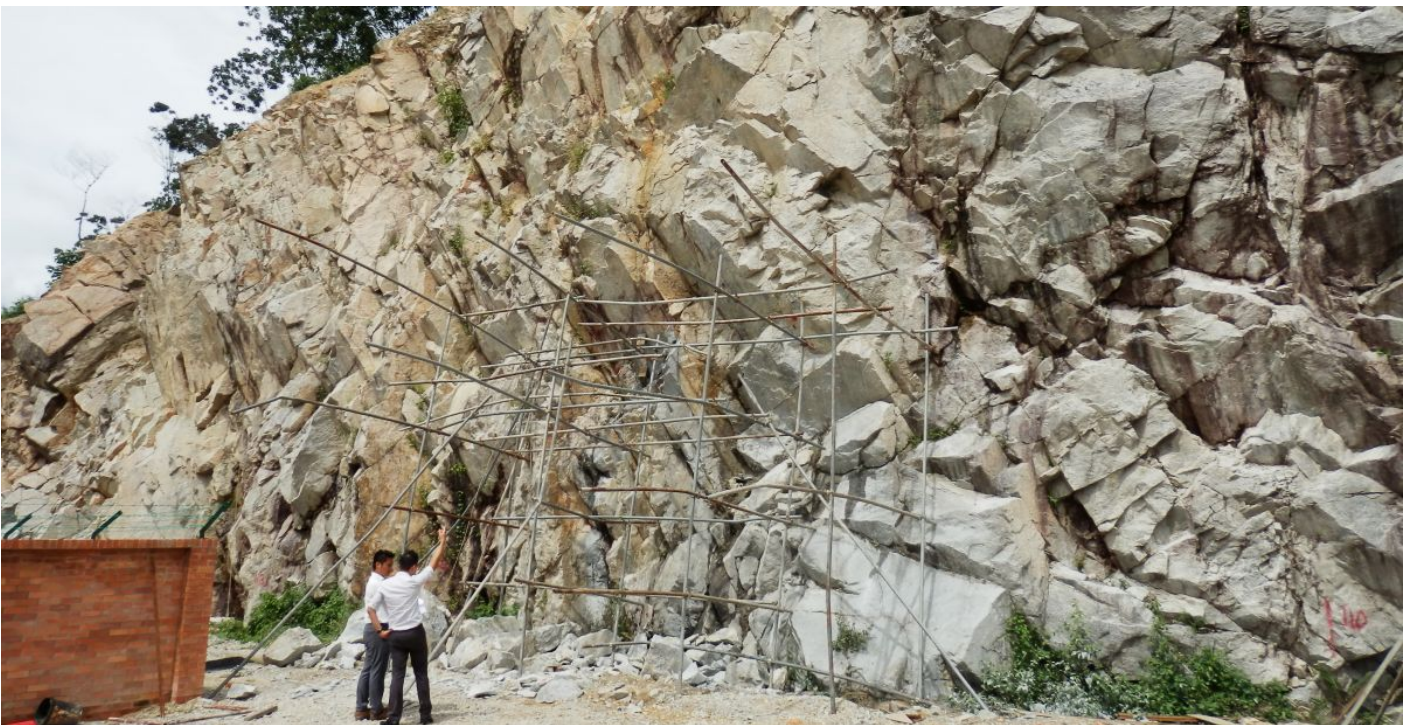
During Construction
