## SLOPE PROTECTION AT KG BAWONG, SUNGAI SIPUT, PERAK SUNGAI SIPUT, PERAK, MALAYSIA

### Slope Protection

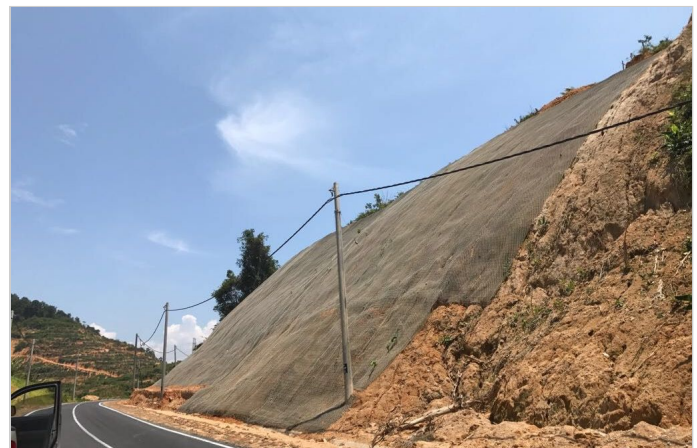
During Construction

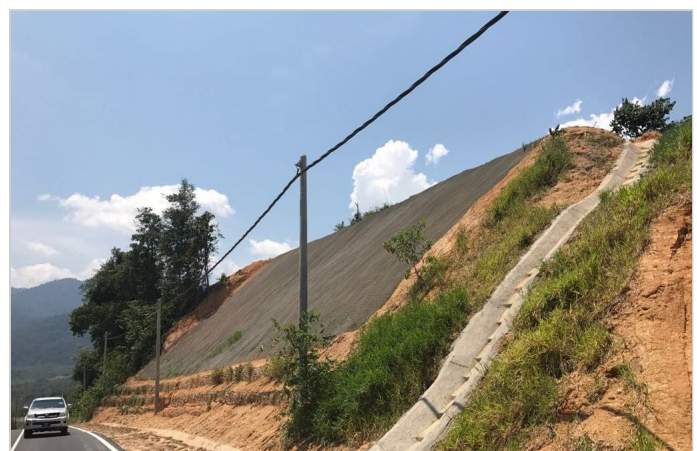
During Construction

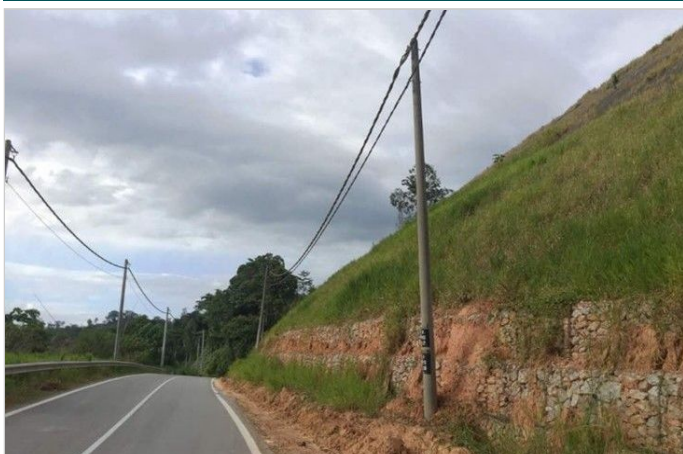
after construction
