ROCKFALL MITIGATION AT TAMAN BUKIT CHERAS, KUALA LUMPUR

KUALA LUMPUR, SELANGOR, MALAYSIA

Simple Drapery

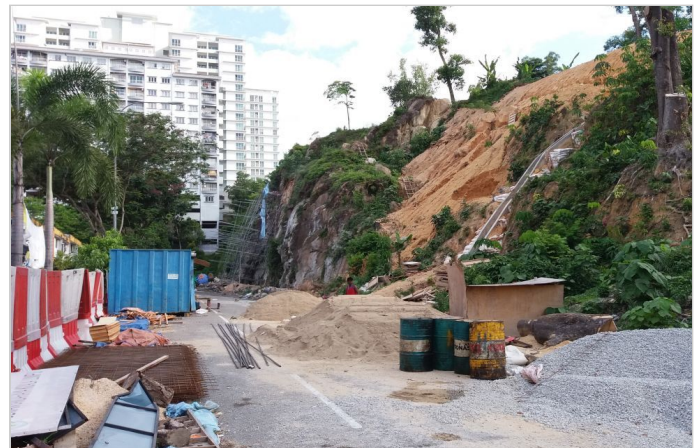
During Construction

Maccaferri supplied an estimated of 2,400 metre square of Steelgrid HR 100 to address the failure of the rock slope. The SGHR system is an engineered combination of high strength steel wire mesh and high tensile wire rope which offers a volume of stiffness. The Steelgrid HR system was installed mainly to strengthen and prevent detachment of loose rocks from the estimated 18 to 20 metres height slope surface.

The Installation of the system is very much straight forward as the adjacent rolls of mesh does not require any form of overlapping however the mesh will be connected side by side using our Hr-Link.

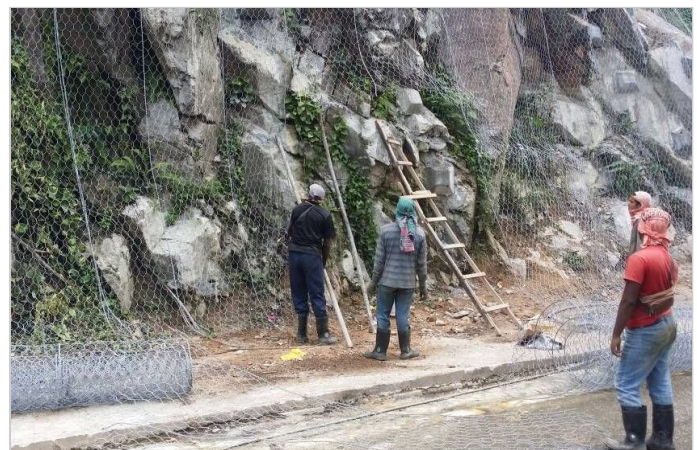
During Construction

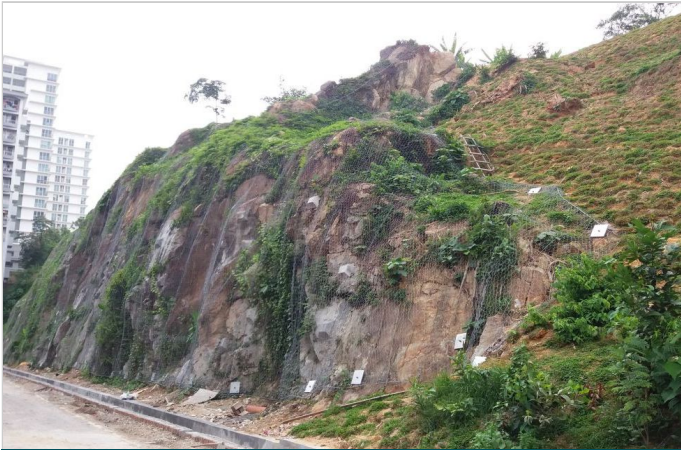
after construction

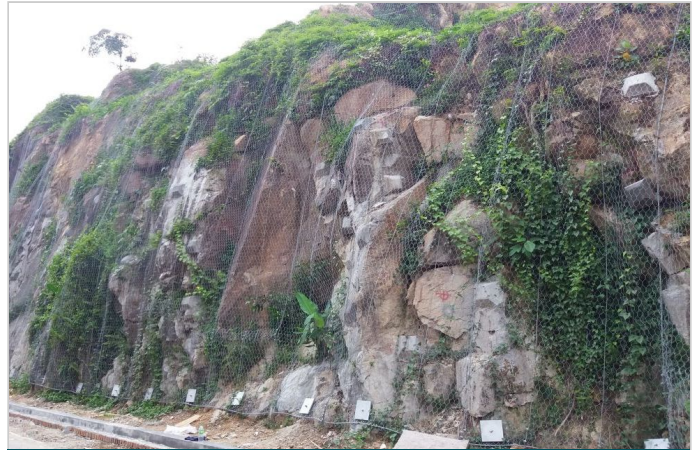
after construction
