SLOPE REPAIR WORKS

CHEMBONG, NEGERI SEMBILAN, MALAYSIA

GEOTECHNICAL ENGINEERING

Product: GREEN TERRAMESH

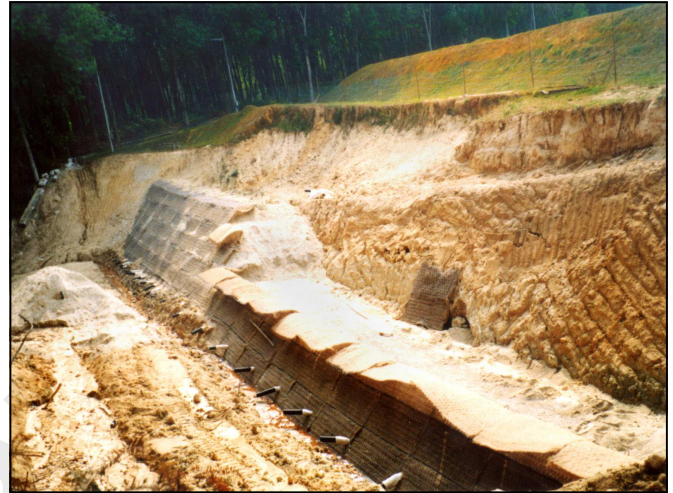
A slope near the Tenaga Nasional Berhad (TNB) Substation at Chembong failed after a heavy downpour. This is the second failure from a 3m high reinforced concrete retaining wall. A soil investigation confirmed that the failure was due to the high ground water table.

Before construction

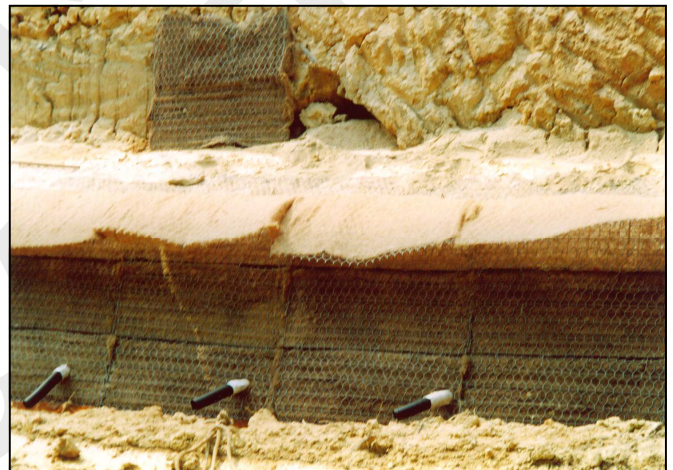
During construction

The client approached Maccaferri to seek our technical advice and design services. We proposed a 3.6m high, 45° angle Green Terramesh reinforced slope. Sub-soil drainage system had to be closely spaced at the bottom of the slope to cater for high water table. Additionally, granular fill was used throughout the reinforced soil zone.

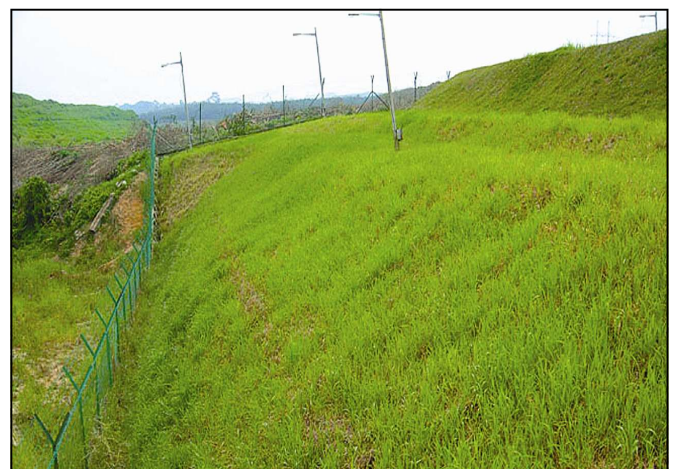
After construction

The Green Terramesh System was chosen due to its cost effectiveness and technically proven design. The construction of the slope took only about two (2) months. The completed slope surface is covered with full-grown vegetation in less than six (6) months thereafter, as seen in the picture.
