## SOUTH PEAK VILLAGE

### SAN PEDRO, LAGUNA, REGION IV-A, PHILIPPINES

#### Reinforced Soil Walls and Slope Reinforcement

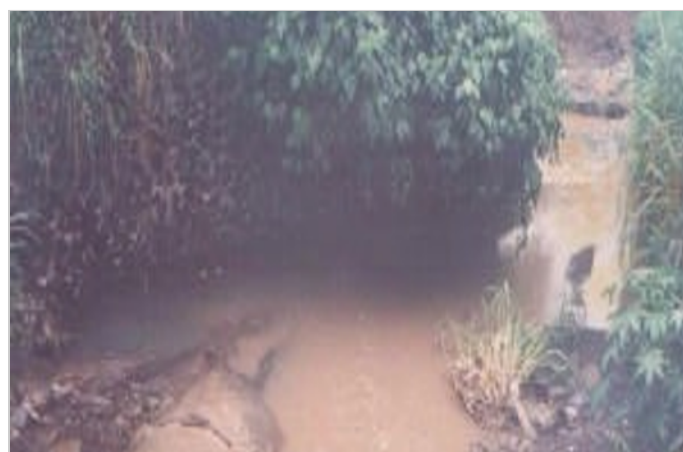
Before Construction

A six-meter high stone masonry wall along a creek inside the South Peak Village in San Pedro, Laguna, Philippines has collapsed and thus required urgent rehabilitation. The said wall was designed to support the saleable lot for residential development. Build up of excess pore water pressure behind the wall was the main reason of wall failure as per the post-failure investigation.

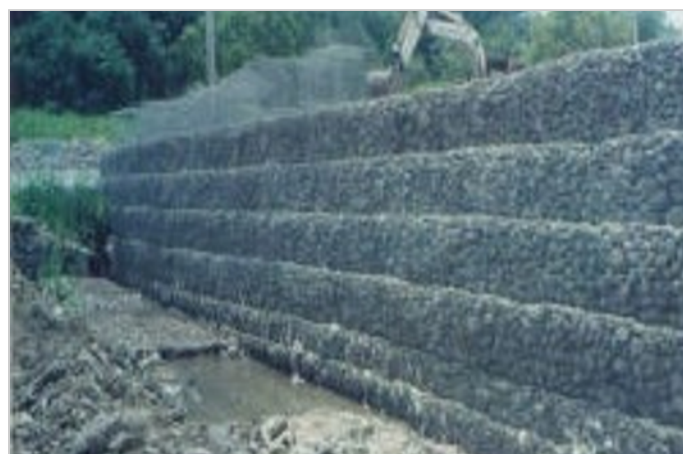
During Construction

FLI engineers explored all possible alternatives to the failed stone masonry wall. Maccaferri engineers proposed a new wall concept - the mechanically-stabilized earth wall, using Terramesh units. Upon review of FLI engineers, the design was approved considering integrity, economy, and ease of installation even on rainy season.

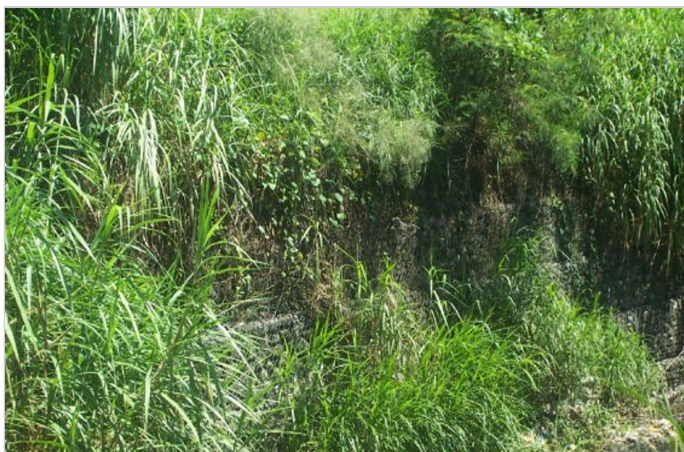
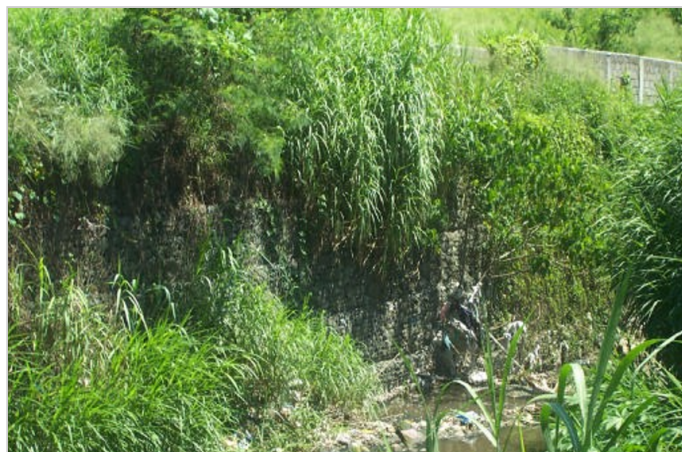
After Completion

Moreover, the other advantages of the Terramesh system MSE wall over rigid structures are: 1) it reduces build-up of excess pore water pressure behind the wall, 2) it is a flexible structure (allows certain degree of movement), 3) it can be installed easily even by unskilled workforce; 4) it is an environmentally-sound solution that encourages the growth of vegetation and fauna, and 5) aesthetically-looking finish of wall surface.
