## HALSEMA HIGHWAY

### HALSEMA HIGHWAY, BENGUET, CORDILLERA ADMINISTRATIVE REGION, PHILIPPINES

#### Reinforced Soil Walls and Slope Reinforcement

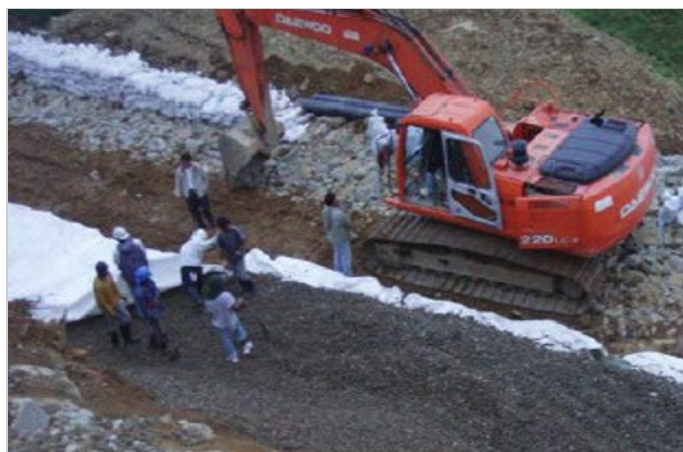
During Construction

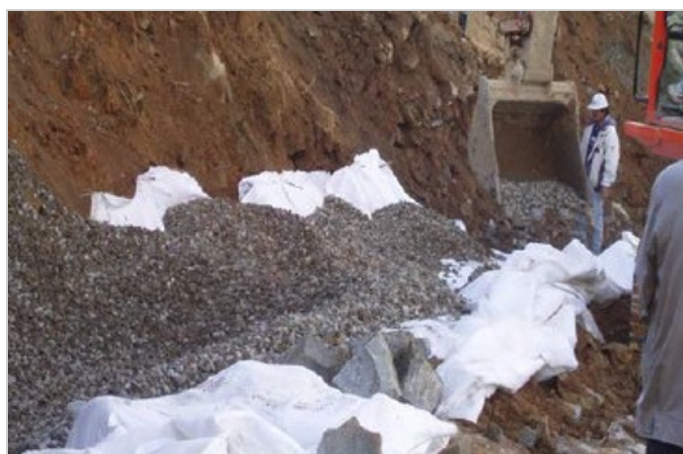
During Construction

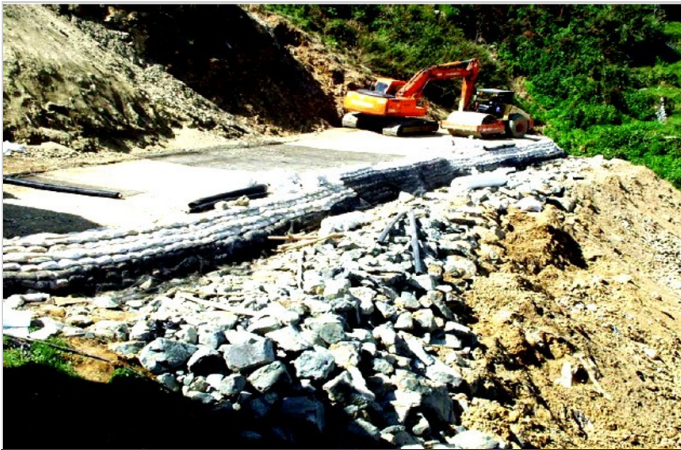
During Construction

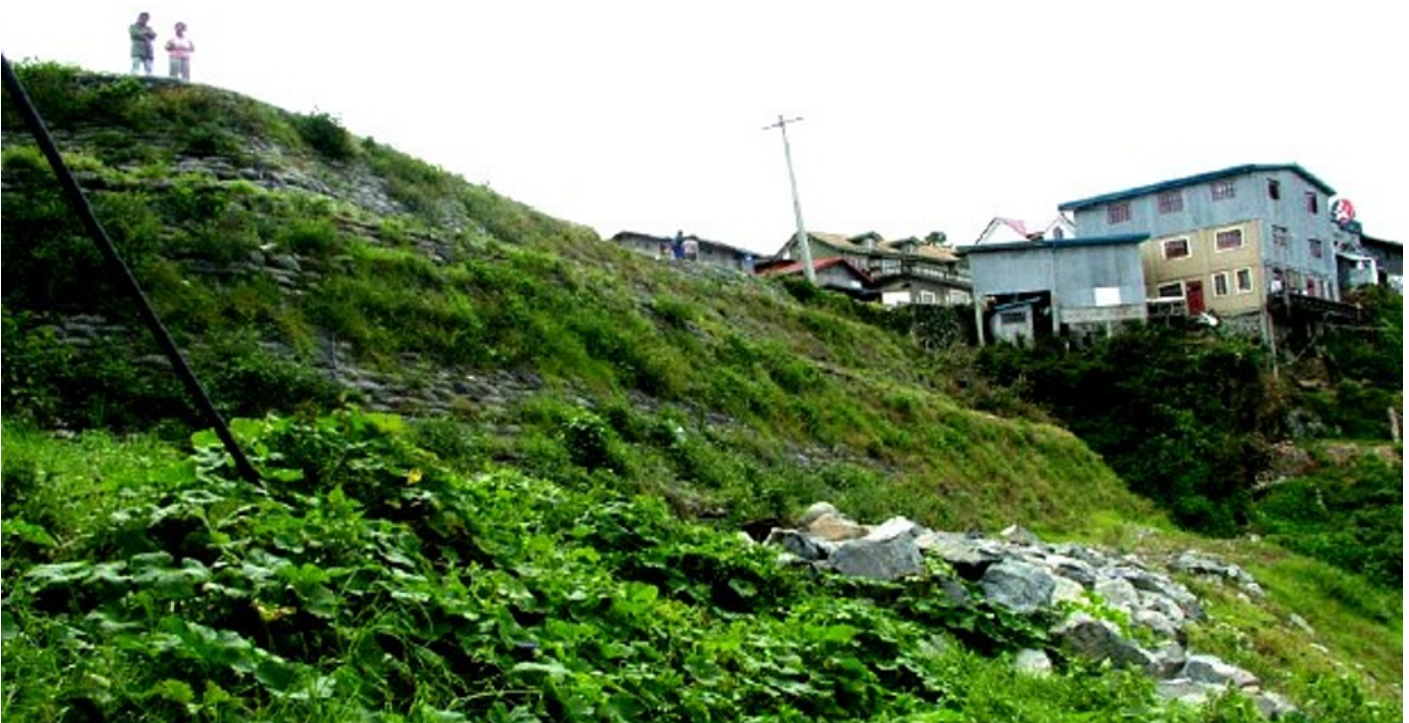
After Completion
