## Longitudinal Protection

In the province of Laguna, CBK Power Company Limited (CBK PCL) operates three hydroelectric power plants. The reservoir of the power plants created the Caliraya Lake, bounded by the towns of Lumban, Kalayaan, and Cavinti. A portion of its tailrace canal, or a water channel below its dam, that serves as the main channel of water coming from the dam and also serves as the main passageway of floodwater coming from different villages leading to the Pasanjan River has collapsed and required immediate rehabilitation.

The Project Consultant, in coordination with Maccaferri, recommended a gabion gravity wall for longitudinal protection. Polymeric-coated gabions were used to ensure durability of the metallic wires exposed to water from the the tailrace canal.

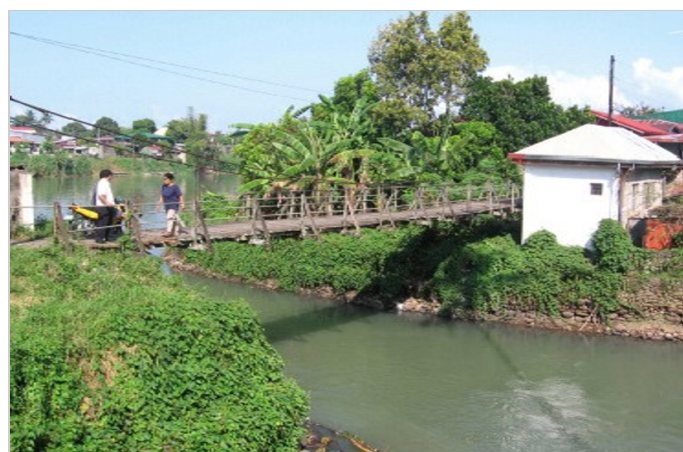
Before Construction

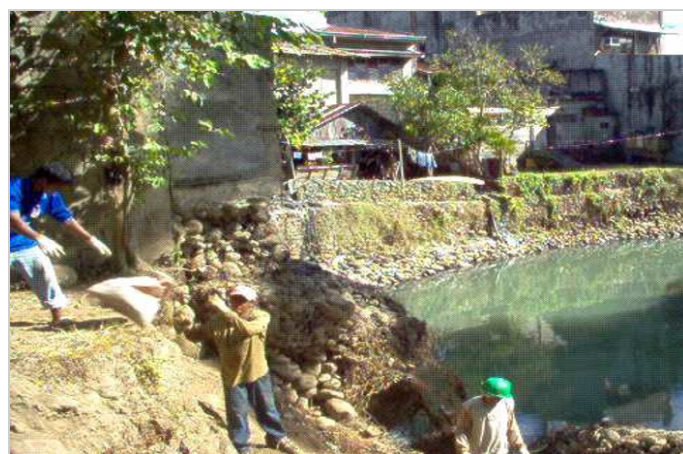
During Construction

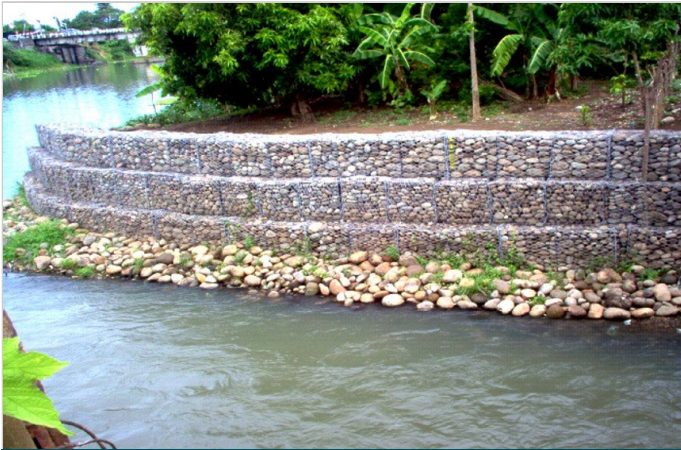
Project Completed

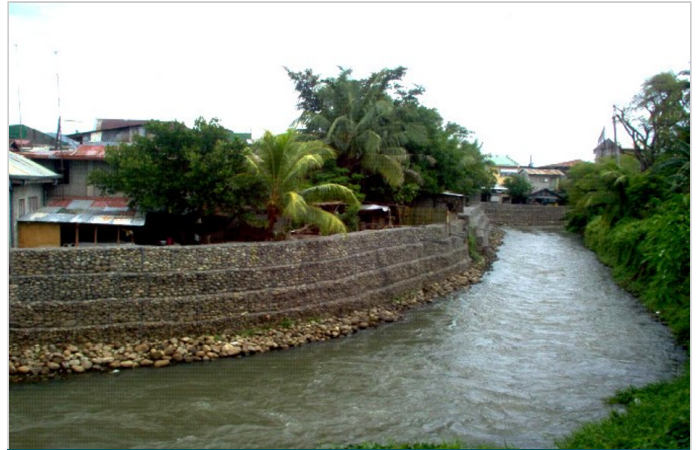
Project Completed

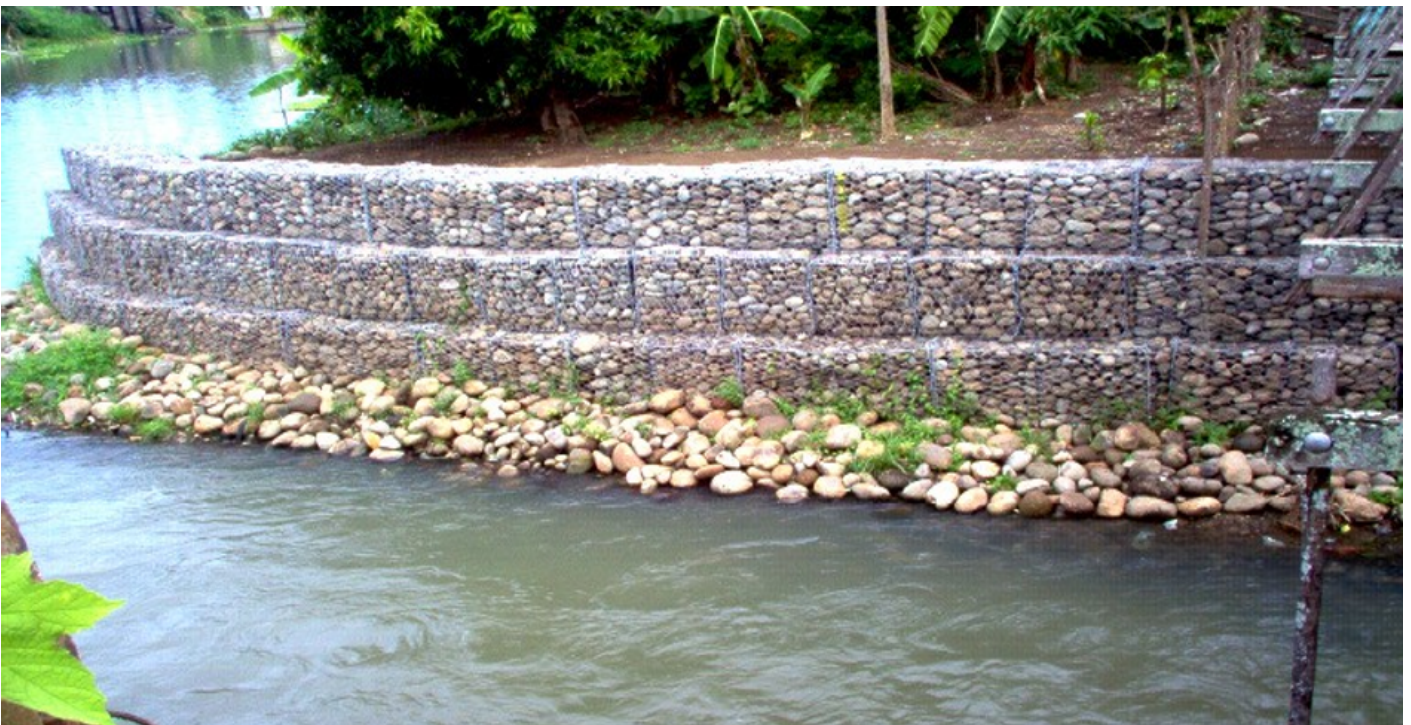
Project Completed
