NL-BERGEN BERGEN, NORTH HOLLAND, NETHERLANDS

Slope Protection

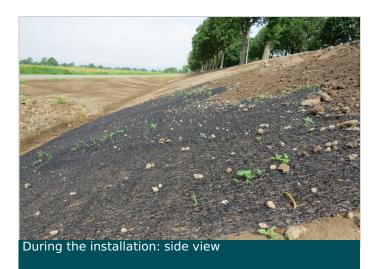
During the installation: unrolling phase

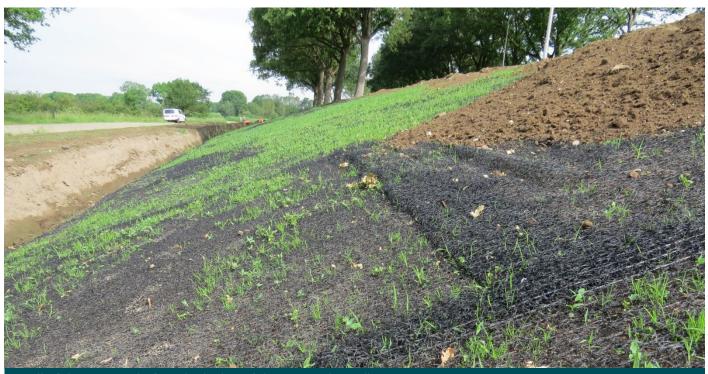
Detail of the MacMat before the laying of the vegetative soil
