CASE HISTORY Rev: 1, Issue Data 25.06.2019

## R3 ORAVSKÝ PODZÁMOK HORNÁ LEHOTA, BANSKÁ BYSTRICA, SLOVAKIA

## Mass Gravity Retaining Walls

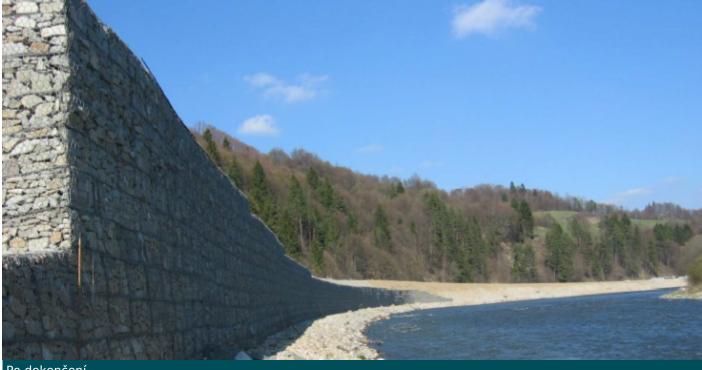
Po dokončení
