A5130 BUSWAY PARK & RIDE MILTON KEYNES, BUCKINGHAMSHIRE, UNITED KINGDOM

Reinforced Soil Walls and Slope Reinforcement

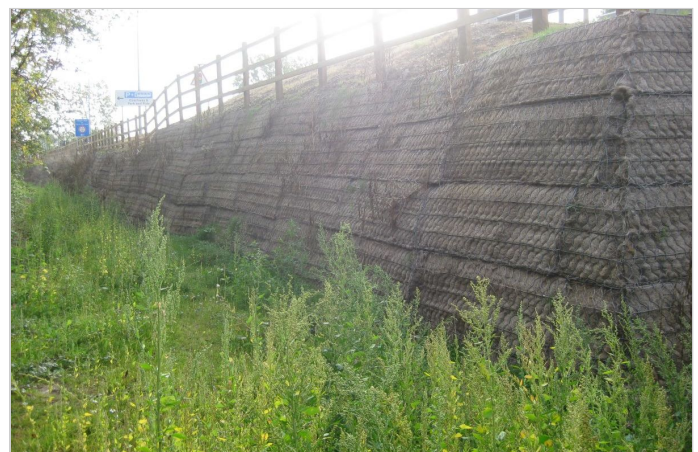
After Construction

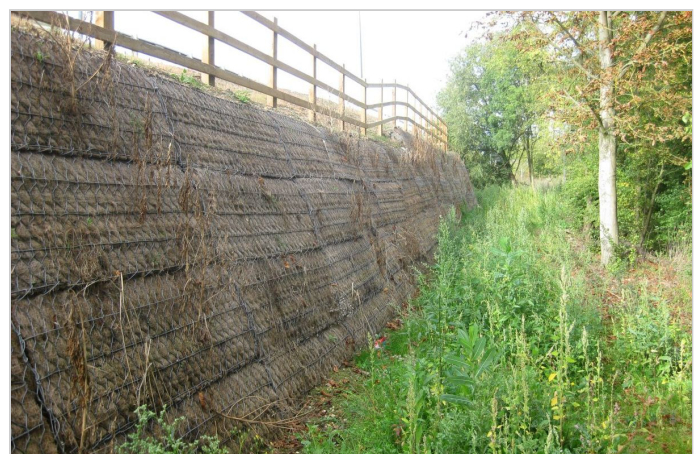
Immediately after construction

The Green Terramesh® reinforced slopes provided the steep-faced green solution and were straightforward to install within the tight construction schedule. It readily accommodated the differing site levels and its flexibility allowed the construction of crisp 90° returns to the pedestrian under-bridge as well as gentle curves where the Green Terramesh® slopes merge with the Northfield roundabout and Busway access road.

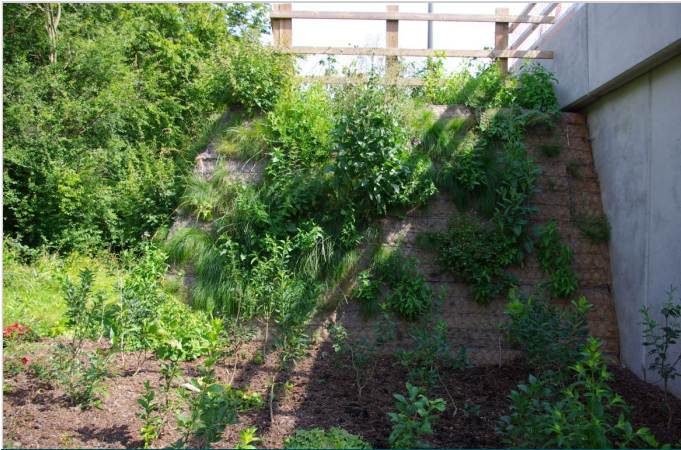
Early signs of vegetation establishing

During installation, the topsoil wedge behind the face of the Green Terramesh® embankment was impregnated with a selected seed mix and vegetation rapidly established to an extent where the structure was barely visible beneath the natural cover.

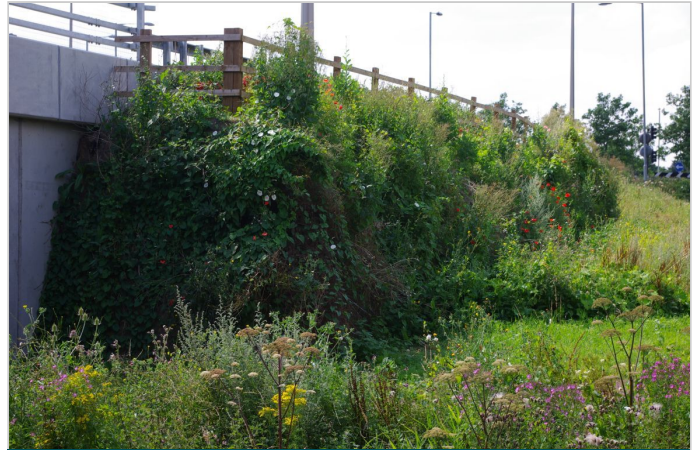
One year after construction

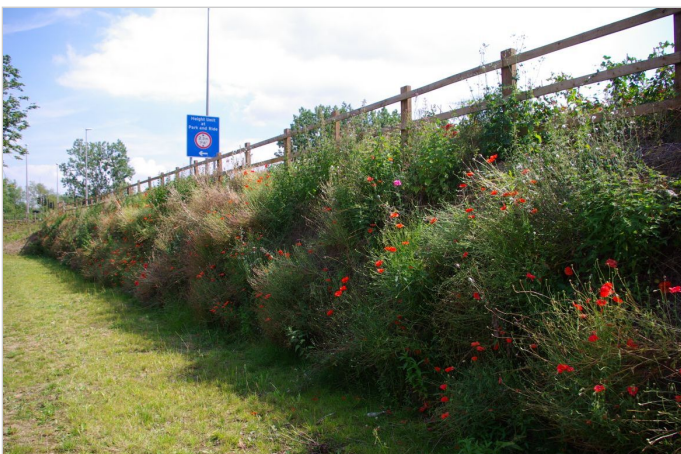
One year after construction

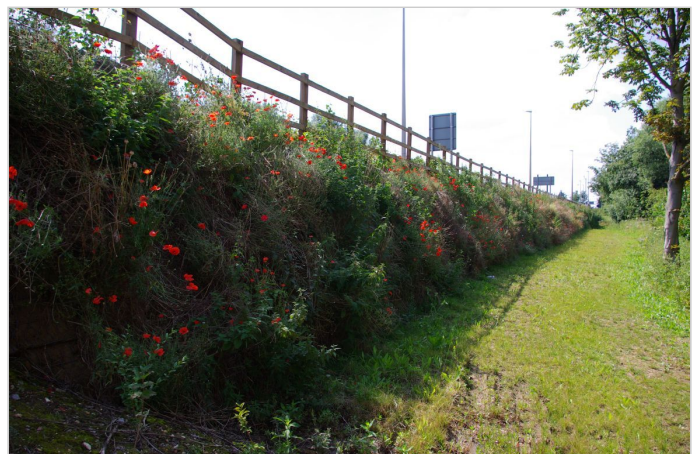
One year after construction
