### SIBLEY MEMORIAL HOSPITAL WASHINGTON, DC

#### RETAINING WALLS - "GREEN" ENGINEERING

**Product:** GALVANIZED GABIONS / BIOMAC C

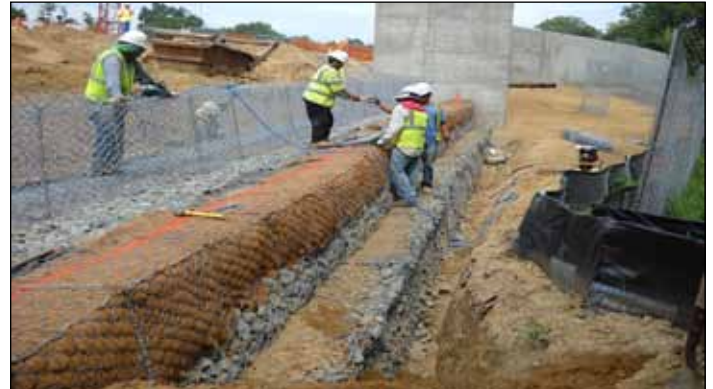
During Construction

The design called for vegetative pockets in the front steps of the gabion wall. The corners of the gabion steps were to be filled with a mixture of stone and soil. The soil was to be held in place by a coconut matting, BioMac C, until vegetation could be established. This heavy erosion control matting has a durability of 3-5 years.

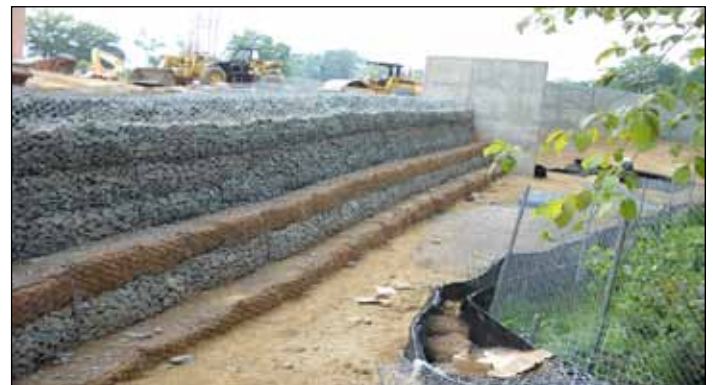
During Construction

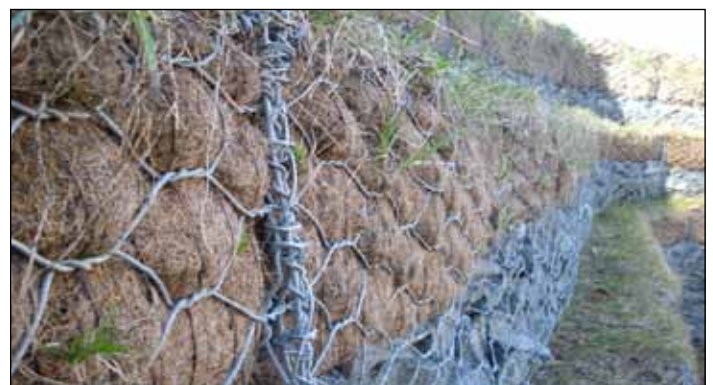
Vegetation Growth

Although the entire project was not scheduled for completion until late 2010, the gabion wall was completed in late summer 2009. The gabion wall is fully functioning and nicely vegetated.
