## CHAPMAN'S PEAK DRIVE CAPE TOWN, WESTERN CAPE, SOUTH AFRICA

### Vertical Walls with Concrete Facing Panels

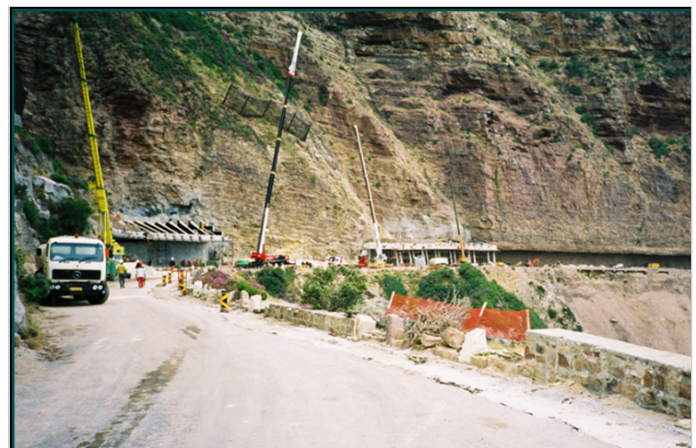
Before gabion construction

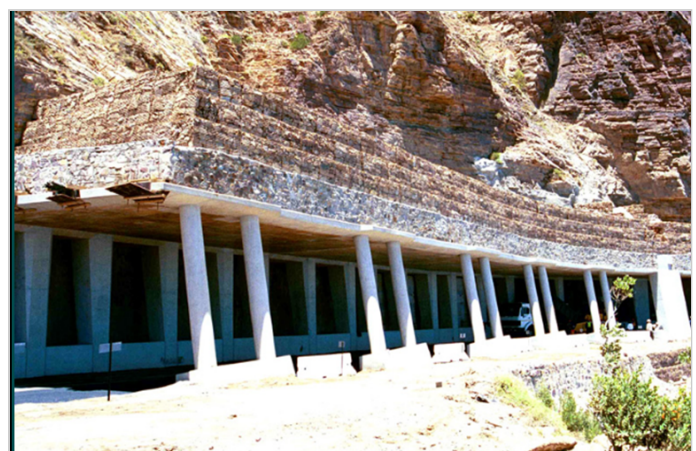
Canopy with gabion impact barrier above

To ensure the durability of the concrete canopies, a three metre-deep earth fill embankment using a gabion mass gravity wall was selected. Completion of the structure was accelerated through the pre-assembling and packing of the gabions off-site whilst the concrete of the canopy was curing.

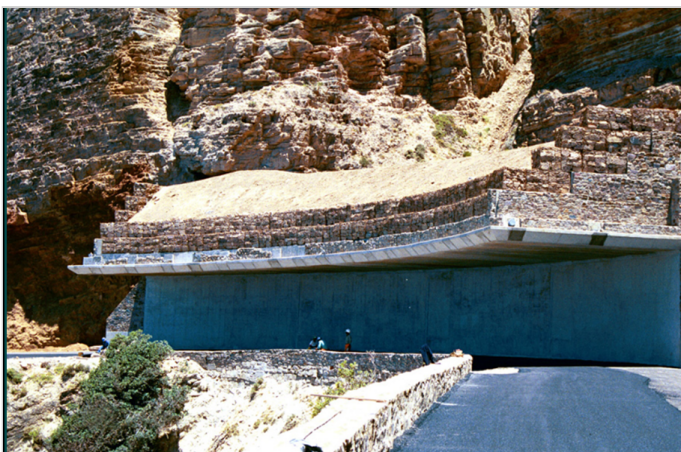
Cantilever structure with gabion impact barrier

These canopies, one a cantilever structure, the other a portal, had to be safeguarded from the impact of falling rocks.

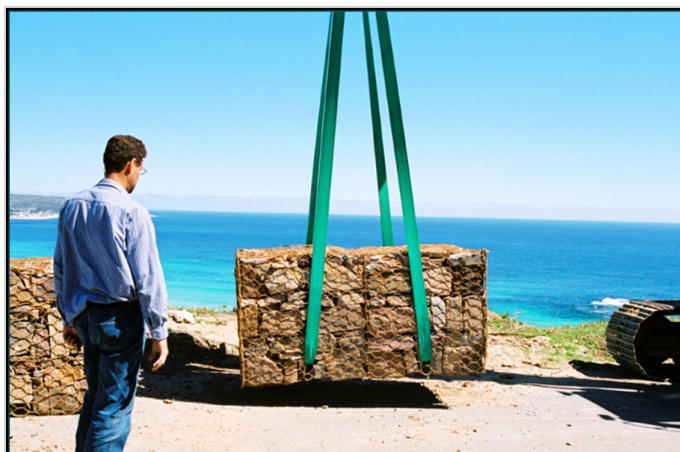
Prefilled units, with PVC pipes, lifted off the ground

Once pre-assembled, the gabions were lifted into place like Lego blocks, and joined together to form the mass gravity wall. PVC pipes in the base of the gabions were used to house the lifting straps.

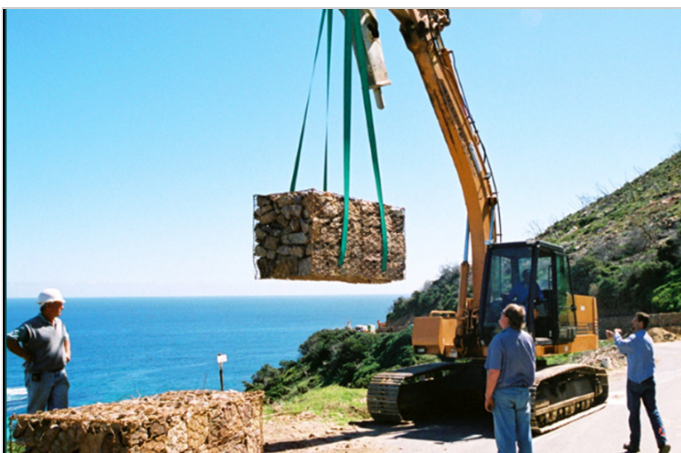
Lifting the prefilled unit

A concern was the deformation of the gabions when lifting took place. Site trials, however, showed that correctly packed hexagonal woven mesh gabions underwent very little or no deformation as the load was transferred uniformly into the gabion.

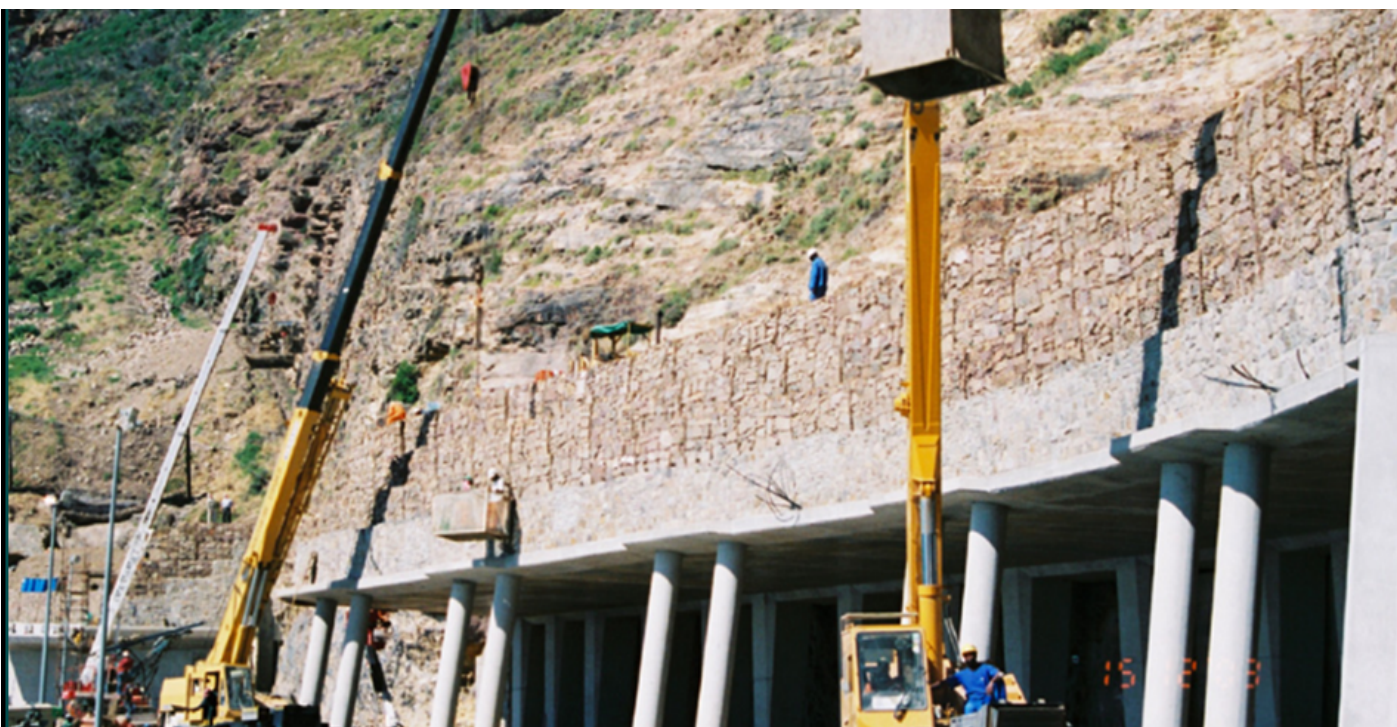
Backfill soil being lifted to fill behind gabions
